INTERIOR

General Description

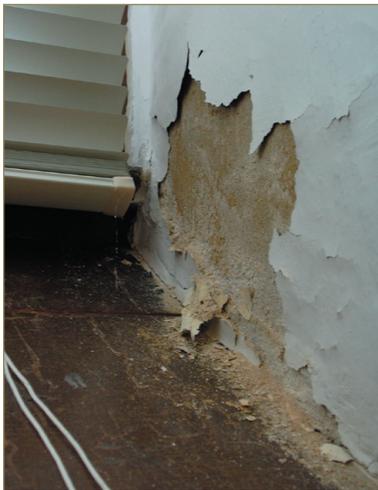
Figure 102: Water infiltration around windows has resulted in plaster flaking.

Other plaster issues are as follows: basement southeast corner office suite (A00-A02) – plaster flaking and buckling are evident around the windows, **Figure 102**. This is likely the result of water infiltration at the windows prior to replacement. The south wall along this office suite and its adjacent vault (A06-7) has plaster damage rising up from the floor line. The plaster is flaking, buckling, and efflorescence is apparent, see **Figure 103**. The smell of mildew in this area and the dampness of the wall observed during rainfall, indicate on-going water infiltration.

Sources of water infiltration should be eliminated prior to plaster repairs. Roofing and masonry repairs will amend many of the water infiltration issues, particularly at the south one-story addition’s connection to the historic building. Regular gutter cleaning, downspout extensions, and landscape material changes will go a long way towards preventing water infiltration on the northeast and southeast corners. Invasive measures, such as the installation of a French drain may be necessary if water infiltration continues to be an on-going issue.

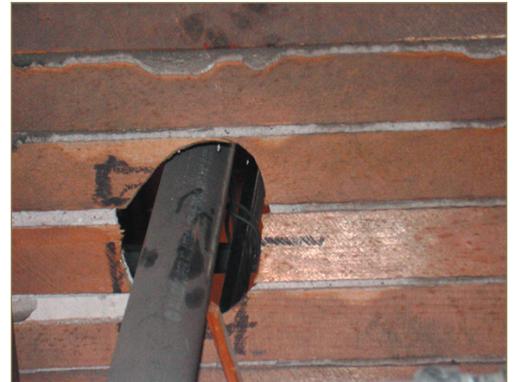
Figure 100: Plaster is poorly keyed.

Delamination – Repair tactics for plaster delamination will vary based upon the level of deterioration, causes, and conservation of decorative detail, see Part Four – Historic Finishes Study, for further details on these techniques.

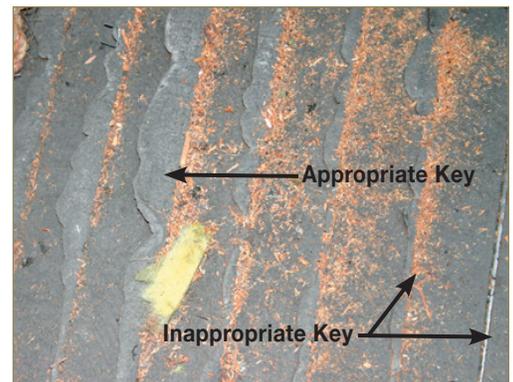
Figure 101: Low levels of plaster pushed through the lath resulting in loose plaster on the County Board room ceiling.

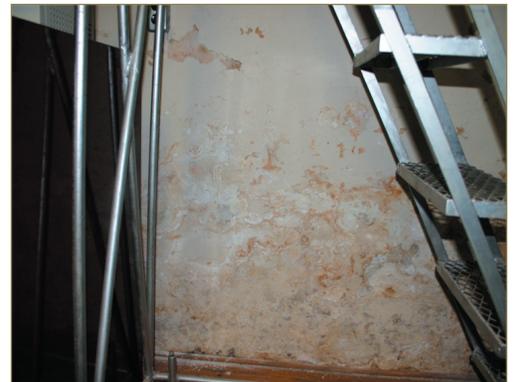
Figure 103: Basement vault (A06-7) plaster deterioration due to water infiltration.

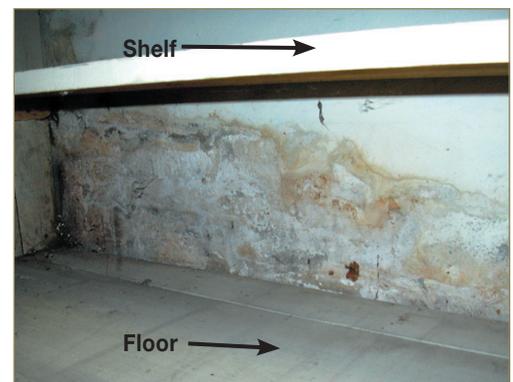
Basement southwest corner office and vault (A113-14) – mildew, efflorescence, plaster buckling and crumbling, delamination, and water staining at the corner junction between these two rooms, **Figure 104**. This is likely the result of water infiltration at the building the seams between the main historic building and the one story storage addition to the south. The gutter on the south wall is bent, indicating ice damming and clogging.

Figure 104: Basement vault (113-14) plaster deterioration and mold growth due to water infiltration.

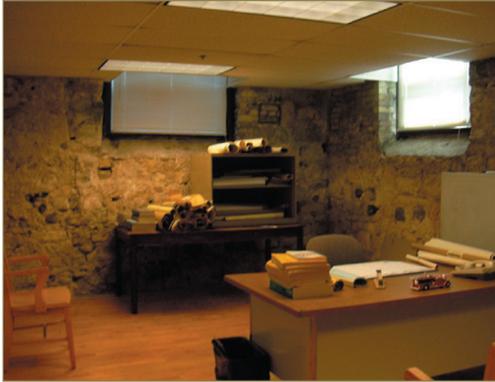
Figure 105: Plaster removed from rubblework stone foundation in northeast basement corner.

Basement Northeast Corner Office Suite (A13/A14) – Plaster has been removed from the walls exposing the original rubblework stone foundation. Efflorescence staining the stone indicates that the plaster on these walls was severely deteriorated from water infiltration. This water infiltration appears to be on-going, **Figure 105**. Causes of this infiltration are also detailed in the *Site* and *Main Roof* sections.

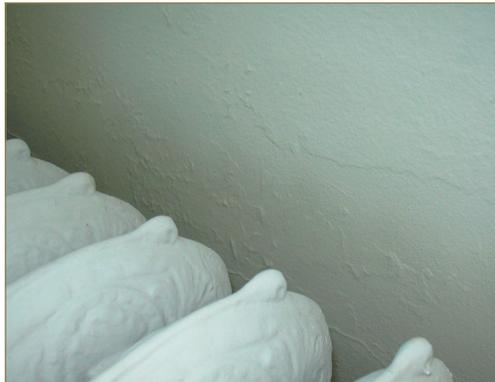
Figure 106: Plaster damage behind radiators from excessive moisture.

Second Floor Southeast and Northeast Corner Offices (A200 and A207) – Moisture from the radiator has resulted in plaster damage behind the east wall radiator, **Figure 106**.

Moisture damage from radiators should be repaired after units and air vents are checked for proper operation. Air vents may need to be replaced and should be replaced every five-to-ten years.

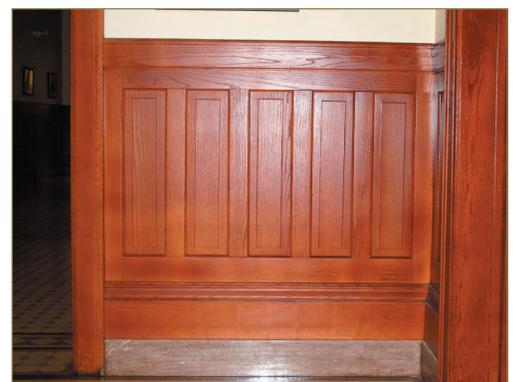
Red oak wainscoting on the first and second floors is generally in very good condition, with the exception of the finish, **Figure 112**. First floor wainscoting is 48-3/4” in height, not including the baseboard. The Second floor wainscoting measures 43-1/2” in height. In the County Board room (A204) radiator leaks and rise and fall in temperature have resulted in cracked and warped panels behind the radiators on the south wall, one panel is loose.

Figure 112: Recessed panel wainscoting after proper refinishing.

Interior Casework, Trim, and Details Recommendations: *All wood casework, trim, and details that have been refinished in the cherry-colored stain should be stripped and refinished to closely match the historic coloration and finish of the wood. Cracks should be filled with a color-toned wood putty prior to refinishing. Special attention should be paid to areas with high levels of exposure to UV rays, such as window sills. A UV-inhibitor should be applied on these surfaces to mitigate future damage.*

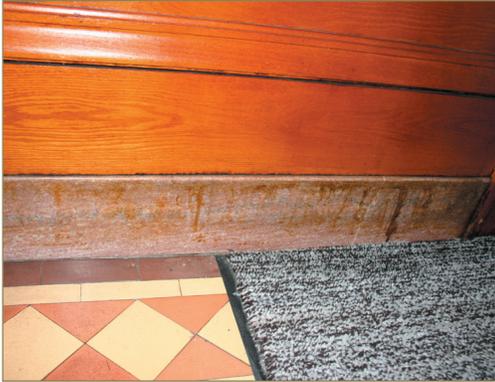
Figure 113: Stained marble baseboards.

First floor corridors and vestibules are lined with a polished-face pink Tennessee marble baseboard, 7/8" thick and 6" in height. This baseboard is intact at all locations and requires cleaning. The refinishing of the wainscoting above the baseboards left run marks and residue over the marble surface and have caused discoloration, **Figure 113**. This color change is also the result of aging, cigarette smoke, and floor cleaning products. Today, the marble is yellowed and has light brown streaks over much of its surface. The baseboard at stair A7 (main vestibule west wall) is fractured.

The marble in all areas should be cleaned with an appropriate stone restoration product specifically manufactured for use on marble. The fracture on the west wall of A7 should be repaired with an appropriate colored silicone. The silicone will allow for movement within the repair while also obscuring it from view.

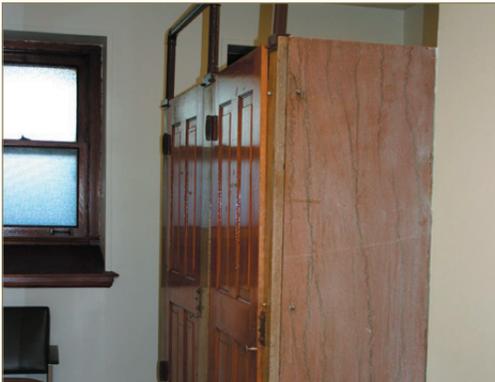
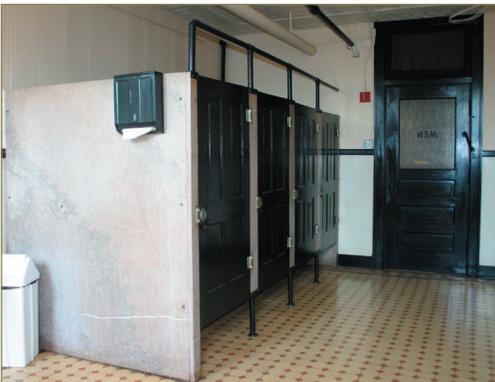
Figure 114: Marble toilet partitions in basement ladies room.

Figure 115: Toilet partitions in basement men's toilet room.

Marble toilet partitions in the basement are in excellent condition, **Figure 114-115**; very few minor cracks are evident. The surface of the marble is stained and has a yellow discoloration, likely the effects of exposure to cigarette smoke.

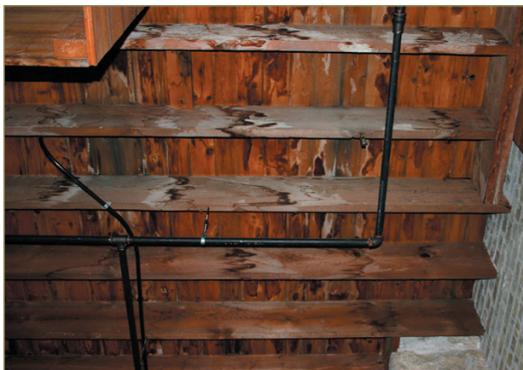
Figure 120: Water damage tower framing and flooring.

The tower floor is rotted in the northwest corner, **Figure 120**. A 1/4” thick piece of plywood has been placed over this area as covering; this is insufficient for weight load and unsafe as this material is not nailed or adhered to the joists or decking.

The attic wood floor should be spot patched to mitigate tripping hazards. Rotted wood in the tower should be replaced with a like-type wood flooring to the original plank.

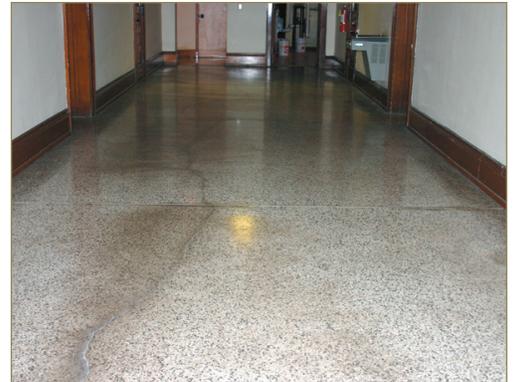
In fall of 1923, the terrazzo floor was installed in the basement corridor (A10) over the monolith concrete flooring.⁴⁷ As the building has settled over the years cracks have appeared in the terrazzo, see **Figure 117**. The flooring is also discolored from years of dirt, grim, and cigarette smoke that typical cleaning techniques cannot remove.

Figure 117: Cracks and discoloration of basement corridor terrazzo flooring.

The terrazzo flooring should be ground and buffed to return the color and sheen to the floor. Cracks can be filled to minimize their presence.

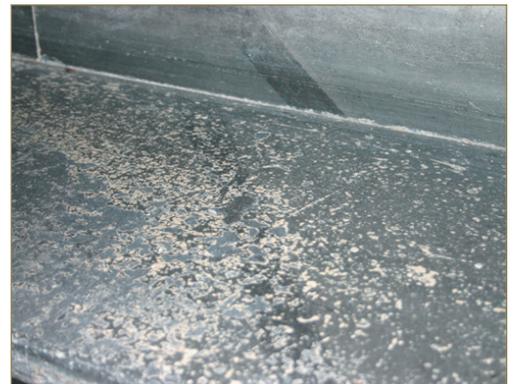
The north entry stair A7 and east entry stairs A4/5 are finished with Pennsylvania black slate. The slate has performed very well over the years. Slight depressions in the treads are the result of 100 years of wear. A thin layer of wax is peeling off of the steps at north entry stair A7, **Figure 118**.

Figure 118: Wax residue on black slate steps.

Peeling wax residue should be cleaned from the black slate steps with a solvent specifically for use on slate.

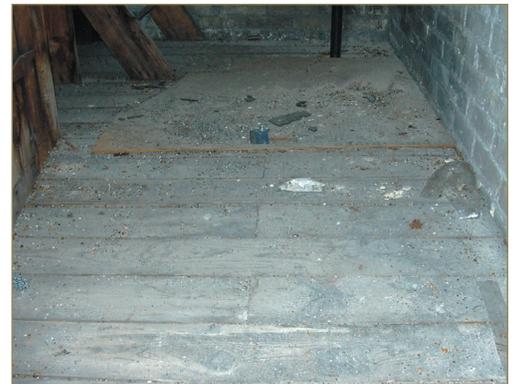
A 1-3/4” x 6” diagonally laid pine plank floor with butt joints was laid in the attic, this floor was left unprotected. The attic flooring is loose or broken in several areas. Some of these areas have been covered with plywood. However, both of these scenarios present a tripping hazard. The tower floor at both interior levels is loose and cupped/warped from exposure to moisture, **Figure 119**.

The tower floor at both interior levels is loose and cupped/warped from exposure to moisture, **Figure 119**.

Figure 119: Tower cupped and rotted floorboards.

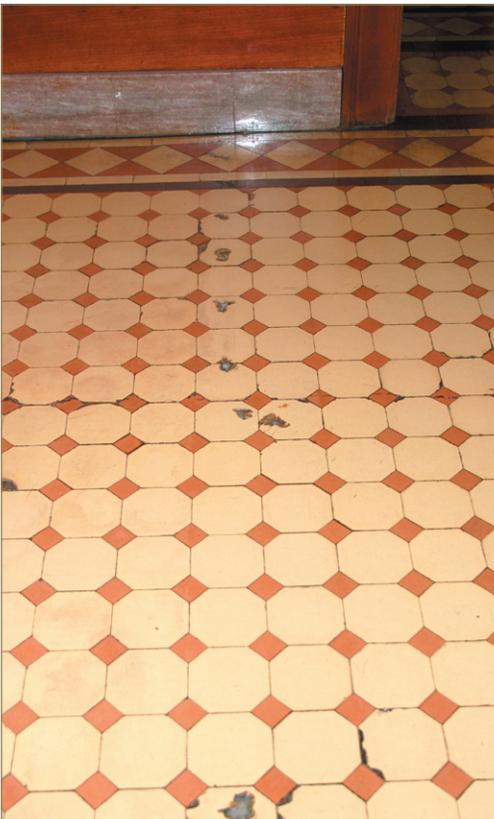
On the first floor corridor (A123B) several holes in the tile correspond to the location of an aluminum and glass partition, **Figure 123**. This partition was removed in 1992-93. In the basement men’s toilet room (A05), several tiles have buckled and cracked in the northeast corner of the room. The concrete sub-floor has cracked and heaved causing this damage. In basement toilet room (A11) a long crack and many loose tiles correspond to the location of a crack in the concrete sub-floor.

Figure 123: Holes in tile floor from aluminum and glass partition.

Damaged tile flooring can be replaced either with reproductions or by salvaging stable tiles from the un-utilized basement toilet room (A11). Heaving and cracked concrete sub-flooring should be removed and patched prior to any tile restoration.

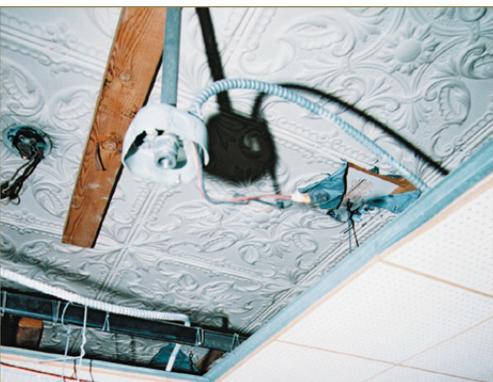
Figure 134: The full extent of ceiling damage and mechanicals should be accessed in further detail.

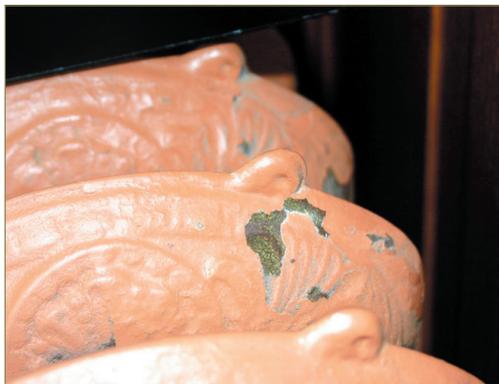
Figure 142: Bronze powder original finish evident under peeling paint.

Recommendations: *Radiators on the first and second floors should be returned to the bronze finish. This apparently subtle change will have a large impact on the overall interior’s integrity.*

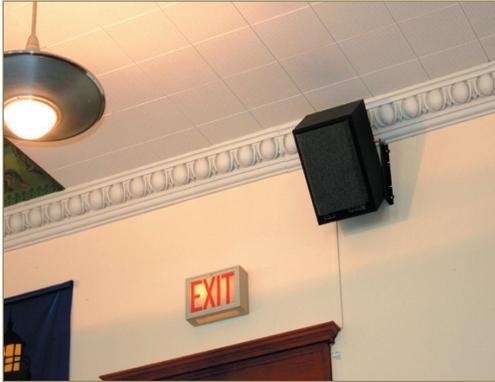
Figure 148: Unsympathetic exit signs. Note the large, black speaker.

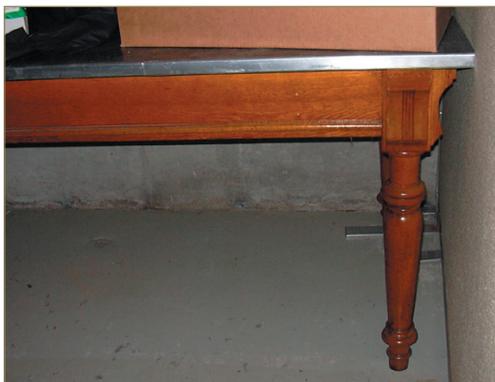
Figure 152: Historic turned-leg table in need of conservation, the stainless steel top was added.

*pieces should be conserved, not stripped, and located throughout the building, **Figure 152**. The bookcase in storage (A201) should be relocated. During restoration of an office the original location of this piece may become evident. The bookcase was likely located in one of the second floor offices, perhaps the original judge's chamber.*

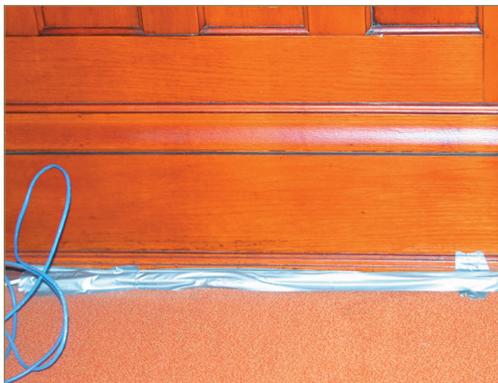
Figure 156: Cable running the length of the west County Board room wall is secured with duct tape..
