INTERIOR

General Description

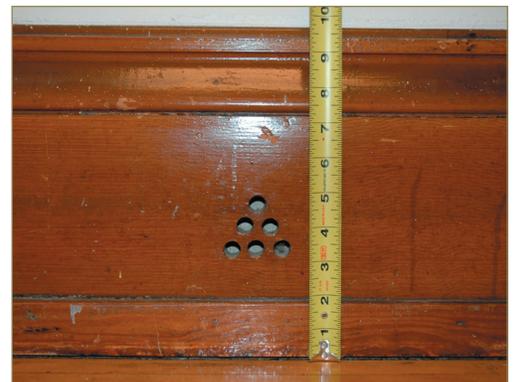
The baseboard in basement office (A13/14) has several sets of triangular configuration circles, **Figure 111**. No specific rationale can be determined for these openings. These holes may be passive ventilation for the air space beneath the wood flooring, between the sleepers. A catch basin in this room would have required venting. No other rooms in the court house contain this detail. The shape of the drill holes indicates these were pre-drilled prior to installation.

Figure 111: Triangular configuration of holes in basement office baseboard.

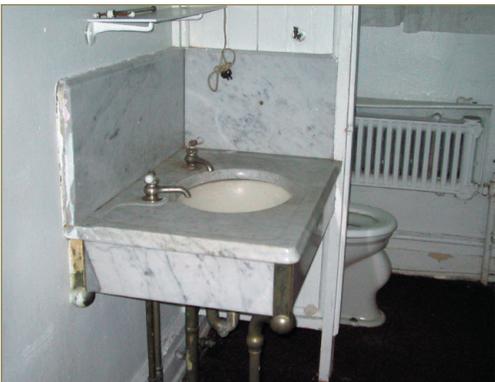
Figure 116: Original washbasin from a building constructed in 1904.

Marble washbasins were once located in all toilet rooms (A05, A11, A12, A205, and A206). These sinks, six in total, were removed at an unknown date. These sinks were originally specified as follows; "*The tops to be one and one-quarter (1 1/4) inches thick, countersunk and molded edge, cut for fourteen by seventeen (14" x 17") basins. Backs to be twelve (12) inches high and seven-eighths (7/8) inches thick of the same kind of marble. Each to have fourteen by seventeen (14 x 17) inches O.O.M.P. basin, R.S. No. 1 N.P. trap Lead,*"⁴⁵ **Figure 116**.

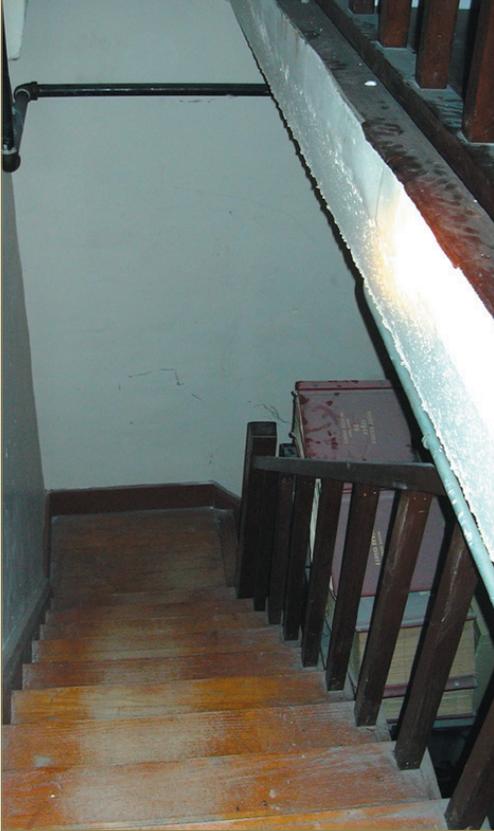
Figure 122: Vault A17 and A110 connecting stair.

An oak stair connects vault A17 in the basement to vault A110 on the first floor, **Figure 122**. The balustrade consists of simple square baluster and a rounded top rail; this stair was added in 1944.⁴⁹ The stair is in good condition and reportedly infrequently utilized.

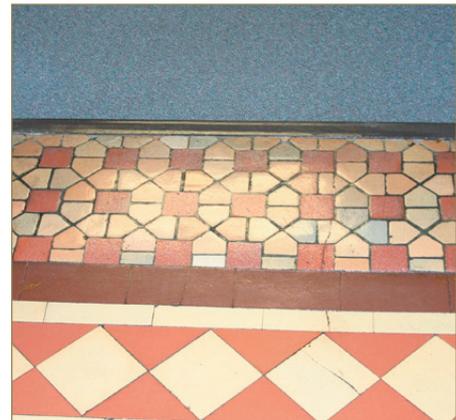
The threshold at the door to first floor office (A118) has a geometric tile pattern unique to the building, **Figure 124**. Investigation confirmed this tile only appears on this threshold. This tile appears historic in manufacture but it is unknown as to the reasoning for this design difference. The tile in this area may have been replaced prior to 1930.

Figure 124: Unique tile mosaic threshold.

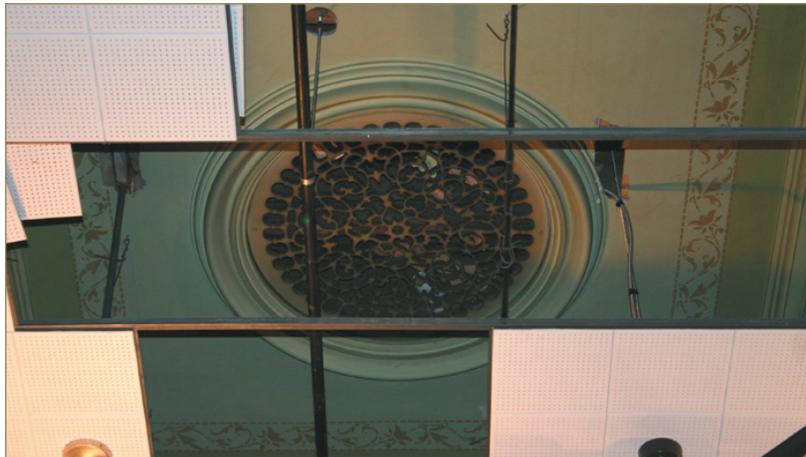
The original basement ceiling height is 9'-7", the dropped height is now 8'-0" in offices. The original first floor ceiling height is 15'-0" (+/-), the dropped height is 9'-4-3/4" (+/-) in offices. The original second floor ceiling height is 14'-0" (+/-), the dropped height is 9'-1" (+/-) in offices. Corridor A208 has a dropped ceiling height of 12'-5". The County Board room (A204, historic Court room) ceiling height is 19'-6" (+/-), the dropped height is 16'-5" (+/-). The original County Board room (A204) has a suspended 12" x 12" ceiling tile obscuring the original painted finish; this ceiling was installed in 1959,⁵¹ **Figure 125-126.**

Figure 125: Ventilator and decorative stenciling hidden for decades behind modern ceiling tiles.

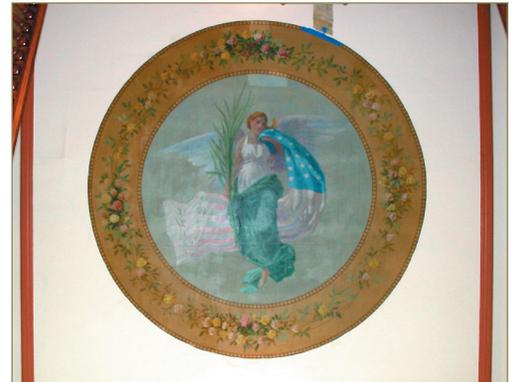
The first floor corridor (A123A/A123B) exists predominately in its historic condition with the greatest change consisting of acoustical tiles glued to the flat portions of the coffered ceilings. The second floor stair (A6) ceiling plaster is still exposed, while only the circular mural of Columbia has been spared from overpainting, **Figure 127.**

Figure 127: Mural of Columbia inspired by the World's Colombian Exposition has never been over-painted, with the exception of a varnish.

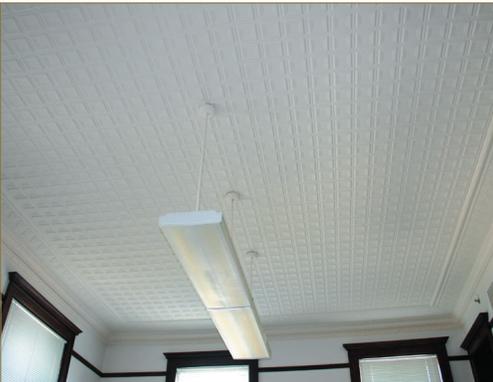
Figure 132: Office A207 intact pressed metal ceiling tiles.

With the exception of the current County Administrator's office (A207), **Figure 132**, basement corridor (A10), and a portion of office (A07), one-to-two additional ceiling finish layers now conceal all pressed metal ceilings. A 12" x 12" acoustic dropped ceiling was installed below the original ceiling line. In 1992, a 24" x 48" suspended acoustical tile ceiling was dropped below the previous layer; this ceiling lines up with the bottom of most of the exterior and interior transom windows cutting them off from view. Parabolic lighting inserted into these ceiling tiles results in a ceiling condition not unlike any modern office building.

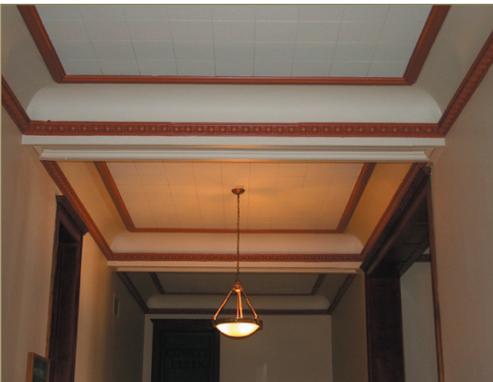
Figure 133: First floor corridor ceiling.

*Glue-adhered acoustic ceiling tiles should be removed from the first floor corridor and the plaster surface restored and painted as appropriate, **Figure 133**.*

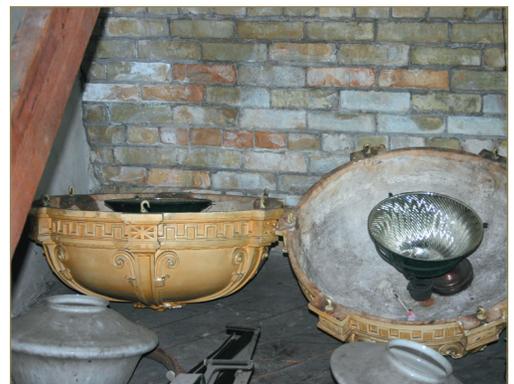
The attic contains several shades and fixtures. In the southeast corner, glass shades of several sizes are stored, **Figure 138**. None of these appear to be original to the building, however, several may fall within the period of restoration. Two plaster bowls with a Greek key pattern also reside in this area and likely date circa 1920s. Two boxes of wall and ceiling mounted fixtures, likely dating to the 1920s, are stored in the raised area above the County Board room ceiling, **Figure 139-40**.

Figure 138: Light fixtures stored in attic.

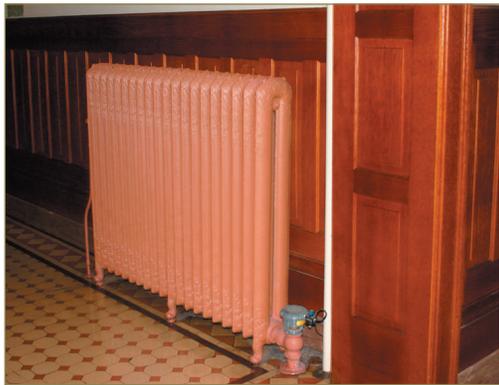
Figure 141: Original radiators with non-original finish.

Historic radiators are located throughout the building, **Figure 141**. Currently, the radiators are all painted white/off-white or light brown. Basement radiators were originally finished with a “dark maroon radiator japan” finish. First and second floor radiators were “bronzed.” The bronze powder is evident beneath current peeling paint, **Figure 142**.

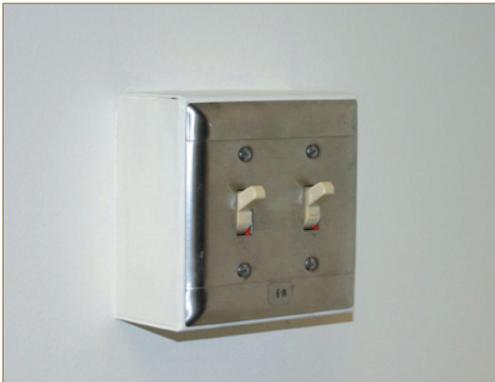
Figure 149: Modern light switch.

Switch Plates and Outlet Covers: Changing the switch boxes and outlets to a more historic configuration seems an unnecessary expense. A more realistic option is to replace all switch plates and outlet covers with a sympathetic historic replica design that blends in with the historic fabric of the building rather than stands out. A change of this nature has a high impact with low dollar costs. A plate that mimics the details of the building such as **Figure 155** can be ordered in all widely used configurations. An antiqued or oil rubbed bronze finish is recommended.

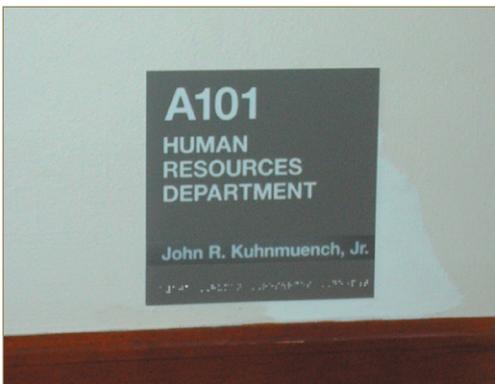
Figure 151: Current signs do not reflect their context.

Room Signs: Wall-mounted code required room signage could be custom designed to compliment the colors and architectural features of the historic building. The wooden projecting signs should be retuned to their original locations. Many of these are now located off-site and should be returned to the building. Those that cannot be found should be replicated. These signs will designate the original room uses of the court house. This technique is often used on historic buildings and should not cause confusion as the required wall signs stating the current use are mounted at eye level. As ceiling conditions are restored, painted transom window signs should be replicated.

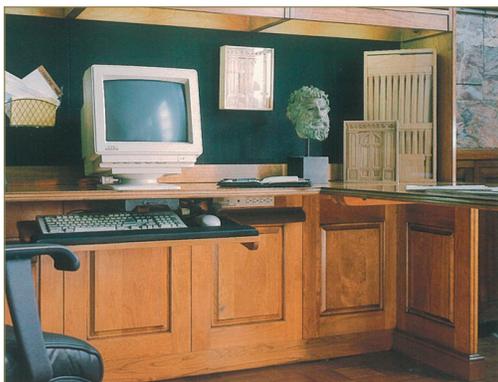
Figure 157: Modern equipment such as a computer monitor and keyboard tray accommodated in a more historically sympathetic manner.

Computers - Future computer equipment should be selected with minimal profile, such as flat screen monitors. Keyboards should be housed in under-surface mounted keyboard trays that are adjustable for the user, **Figure 157**. All CPU's should be located beneath work surfaces or within open shelving units. Locating CPU's on desktops or work surfaces should be avoided. All desks and work surfaces should have grommets to effectively minimize the appearance of cables and cords. Large equipment such as copy machines and printers should be located in secondary areas.
